RUBIX Application Spotlight

Automated Trail Inspection

RUBIX for Trails and Sidewalks

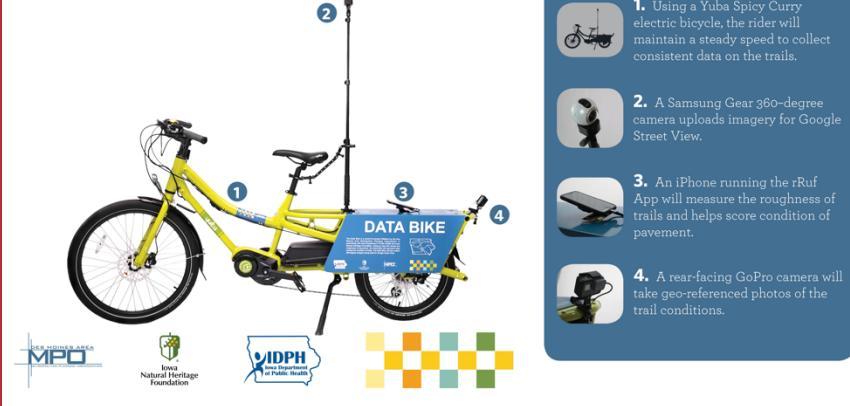
The first "DataBike" powered by RUBIX technologies

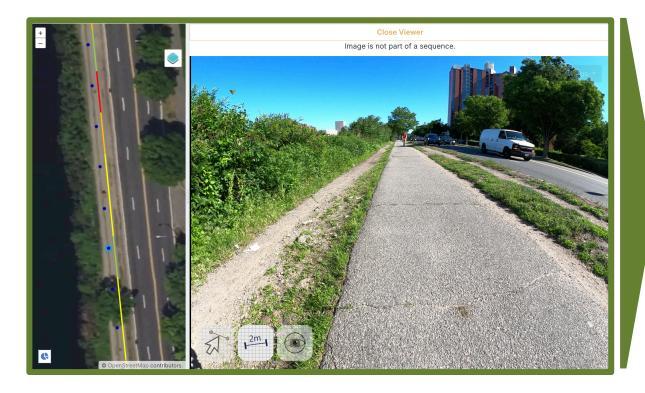
The motion and location information collected from the device is automatically processed and produces a classified Trail Condition Index (TRCI) indicating the relative smoothness of a trail. The TRCI data is represented at different levels of detail, mainly:

- Short Intervals (shown below) used to identify hotspots
- Segments (shown on the right) for network level ranking and analysis
- Groups of Segments for higher level comparison of overall Trail Systems

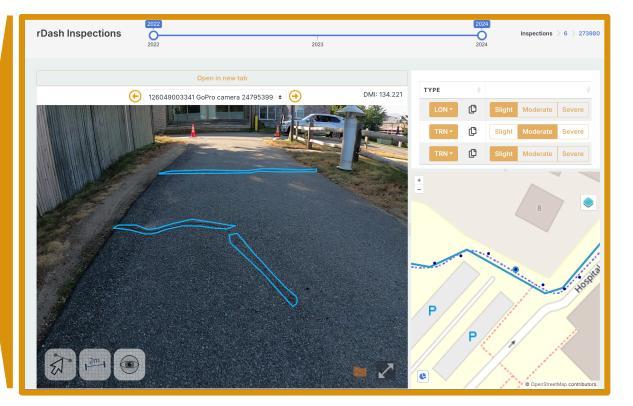
For more advanced analysis, images can be analysed through the RUBIX AI module, **rVision**. This workflow detects more detailed surface defects on trails such as cracking, edge defects, and potholes. These detects are classified in terms of the severity (width of crack) and extent (computed areas or lengths) of the affected areas. These details are further rolled up to produce a Surface Condition Index representing the overall surface quality of a Trail.
